LOWER BEE BRANCH CREEK— TWIN CULVERT REPAIR

DUBUQUE, IOWA

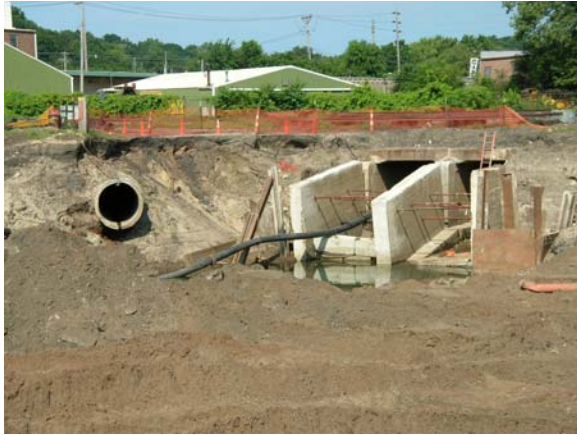
The existing twin 10'x12' box culvert outlet structure at the northwest corner of the 'Old Pack Site' where the Bee Branch extends under the railroad tracks was partially removed as part of the Lower Bee Branch Creek Restoration project. The southeastern end of the culvert experienced excessive settlement.

Twin Box Culvert

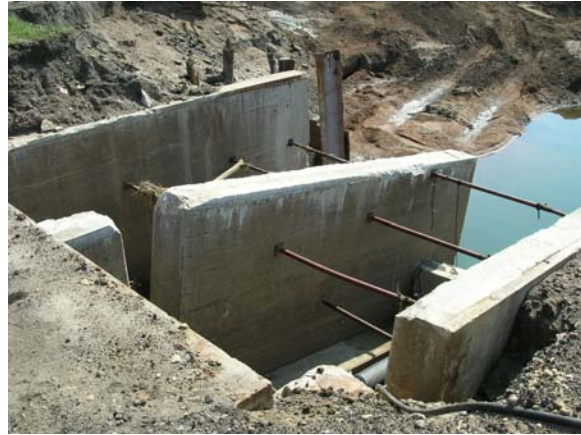
Rotation of Wall Segments

The structural pieces associate with the culvert remained sound. So, it was possible to re-use the northern wall/footing, as well as the precast-like concrete slab-sections. While it was possible to re-use the central wall, it was deemed too heavy to attempt to reposition. Therefore, the central wall/footing and the slab-on-grade was re-cast to provide new construction equivalent to the original construction.
