DAVIS COUNTY COURTHOUSE BLOOMFIELD, IOWA

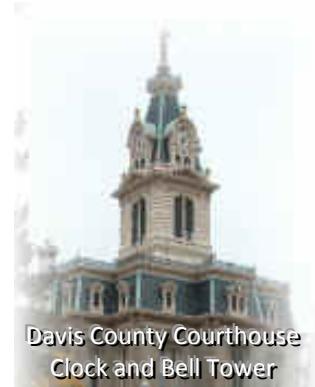
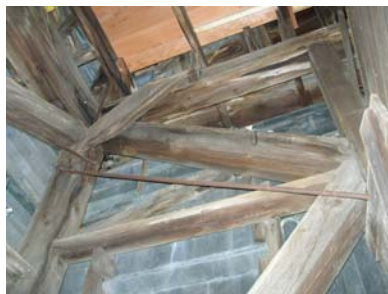
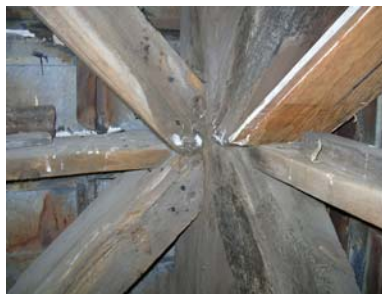
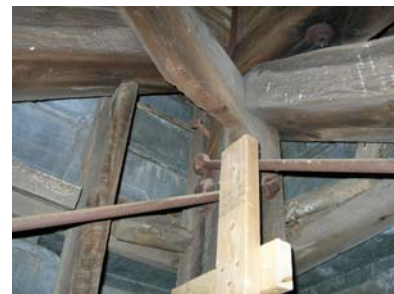
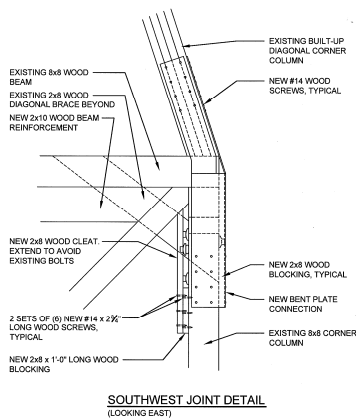
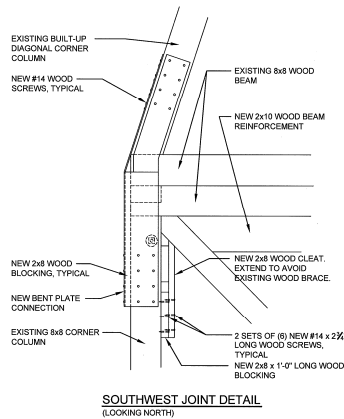
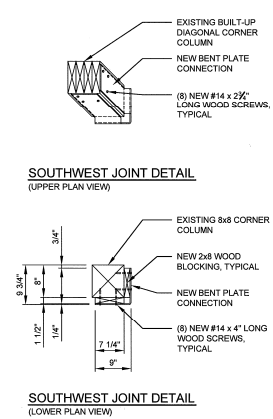
The existing walls and roofs for the Davis County Courthouse leaked. Years of water infiltration deteriorated the exterior metal panels, and well as the interior wood framing. Various roof repair techniques were used in the past to stop water from dropping into the courtrooms below, but most were ineffective, and some repairs simply made the conditions worse.

A more comprehensive plan was develop which incorporated the wall systems, as well as the roof systems. During the renovation, various deteriorated wood conditions were discovered. Ideally, deteriorated wood should be removed and replaced with new members, but the shoring effort was cost prohibitive. So, new wood and steel members and connectors were added to reinforce the deteriorated wood conditions.
