ST. JOSEPH'S CATHOLIC CHURCH – PARISH HALL

LENA, ILLINOIS

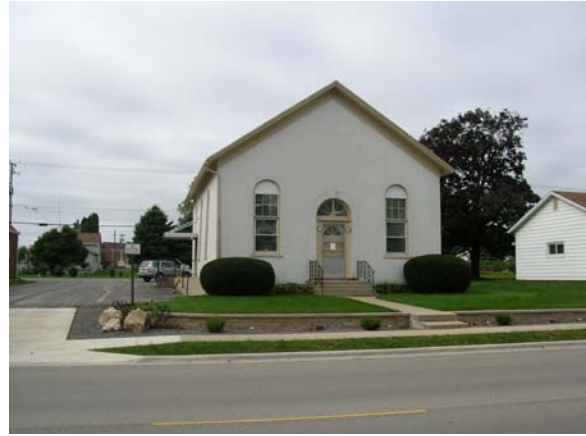
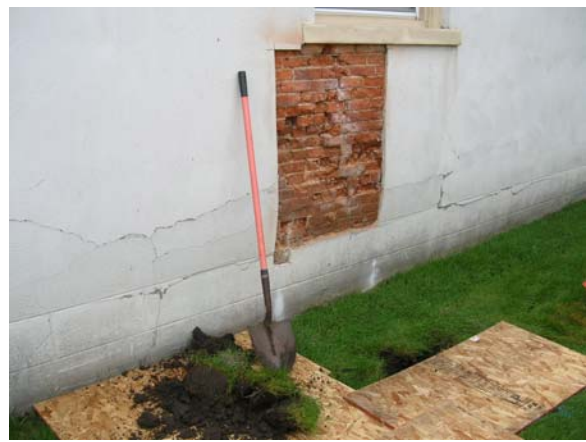
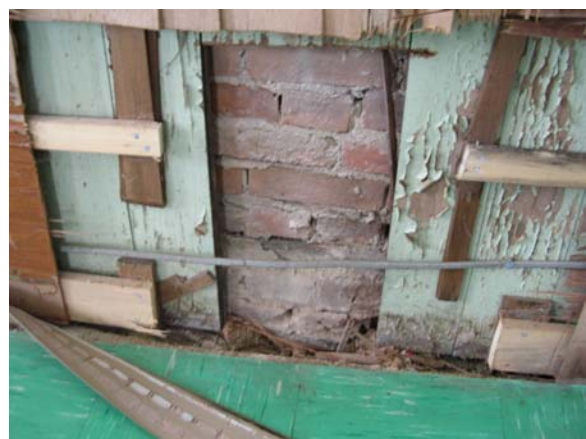
As a result, it was discovered that the rubble/limestone foundation wall extended only 30" into the ground. The exterior surface was roughed. The joints between the limestone pieces were loose. And, there was no footing beneath the wall. Current building code standards dictate that foundations should extend at least 42" below grade with a smooth surface to avoid seasonal frost heaving. The existing foundation system was not capable of withstanding the forces imposed by cyclical freeze-thaw of the saturated clay soils. The freezing caused the foundation wall to heave and move in unpredictable ways.

The brick exterior wall exhibited cracks, spalls, loose mortar, and unusually soft bricks as a result of prolonged exposure to moisture. It appeared that a plaster wall was adhered to the brick wall in the past as a means to cover and reinforce an already water damaged brick wall. While the plaster was able to patch the brick wall, it did not address the root problem, which was the moving foundation wall. Over time, the foundation wall continued to move creating cracks within the plaster, allowing water to infiltrate, and starting the cycle of deterioration all over again.

To save the building "as is", it would be necessary to replace the existing foundation walls, and rebuild the exterior brick walls. Considering the age of the existing Parish Hall, MSA recommended that it would most-likely be more cost effective to replace the building with a new facility constructed of modern materials/techniques, and capable of matching current needs.
