ST. MARY'S CATHOLIC CHURCH ELIZABETH, ILLINOIS

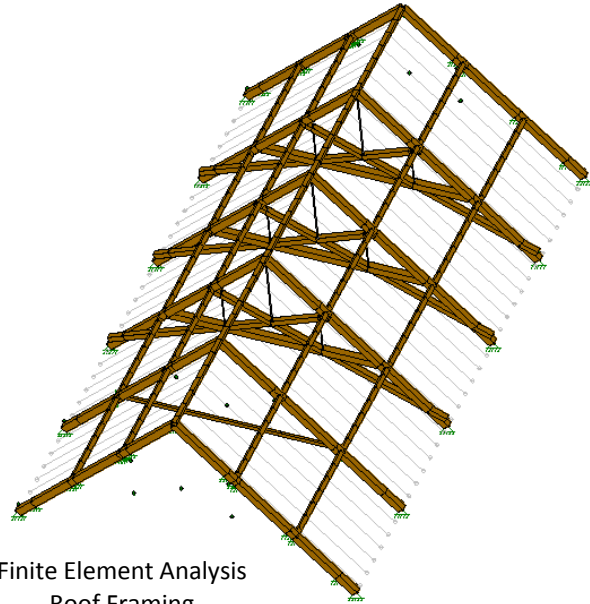
Finite Element Analysis
Roof Framing

A three-dimensional finite element computer analysis of the roof framing indicated that a stronger ridge member directly attached to the roof trusses would enhance the strength and deflection characteristics. So, we recommended that a supplemental ridge beam be installed beneath the existing roof joists, and directly attached to the roof trusses, roof frame, and the exterior masonry wall on each end of the building.

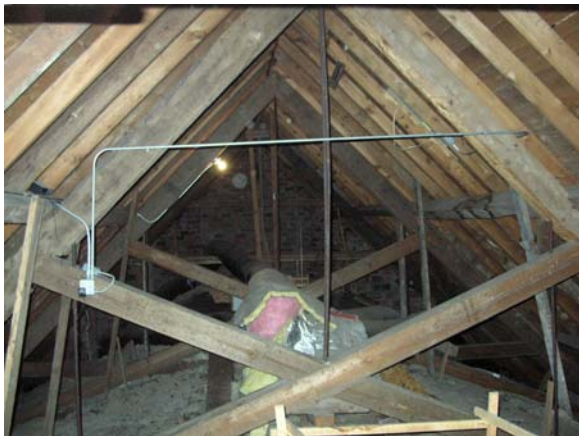
Existing Roof Truss

St. Mary's Church was visited to address specific crack, roof framing and masonry concerns associated with the existing building. Most of the cracks were directly or indirectly associated with the roof framing, which was repaired and possibly modified in the past. The re-application of roof loads associated with the roof reconstruction effort most likely started the ceiling cracks within the apse arch and the wall cracks above the windows. We recommended filling the cracks with a paintable caulk. Re-plastering the cracks would most-likely not be effective, because the crack would redevelop.
