ST. MICHAEL'S CATHOLIC CHURCH GALENA, ILLINOIS

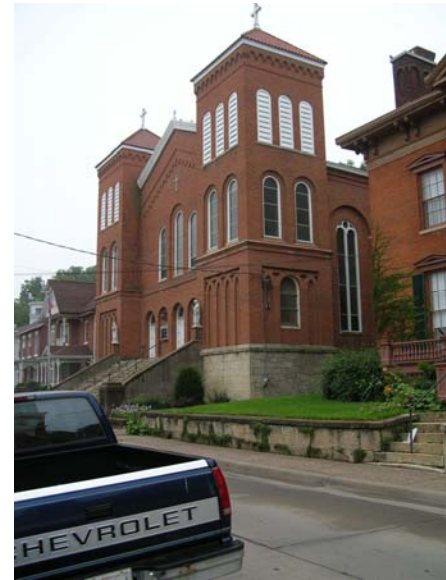
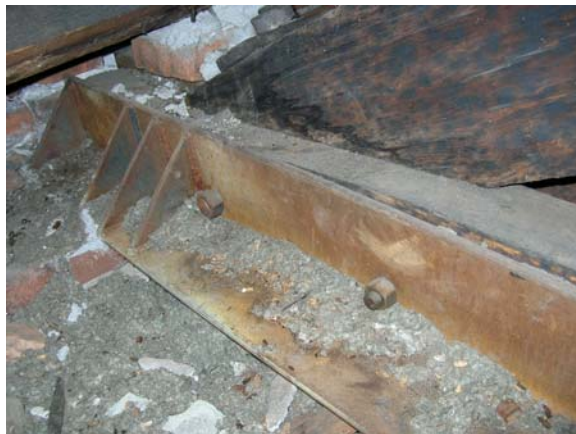
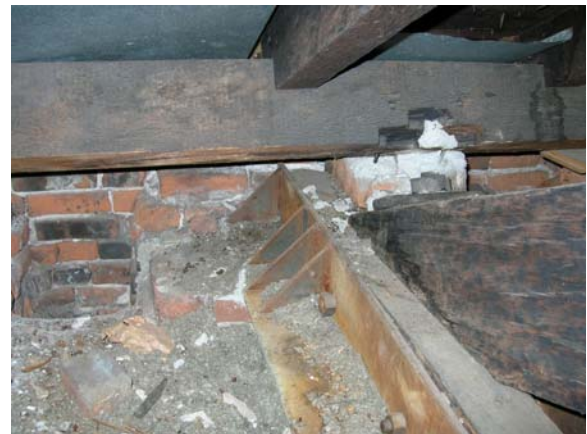
St. Michael's Church was visited to determine the cause of ceiling cracks and differential roof truss movement. Steel reinforcement was discovered at the eastern bearing end of one of the roof trusses that had dropped. Apparently, the bearing condition on the eastern end of the truss failed in some fashion in the past. The actual cause of the bearing failure was not known, but there was obviously a repair, which incorporated new masonry and the introduction of steel angles attached to the bottom chord supplementing the bearing.

Supplemental Steel Angle with Stiffener Plates at Bearing
