BOWLING ALLEY DEMOLITION VIOLA, WISCONSIN

The existing bowling alley building in Viola, Wisconsin needed to be demolished to convert the site to Green Space. An engineering evaluation was performed to assess the existing conditions and propose a means of demolishing the existing building while retaining the structural integrity of the adjacent Old Opera House building.

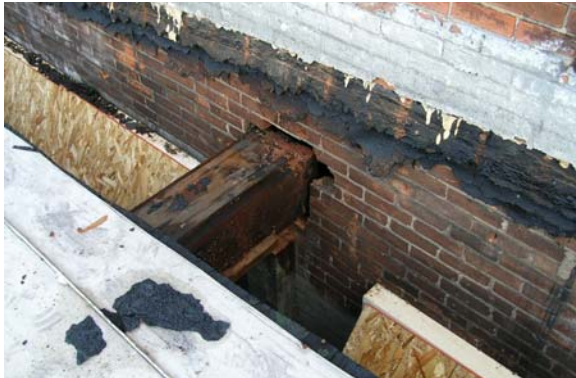
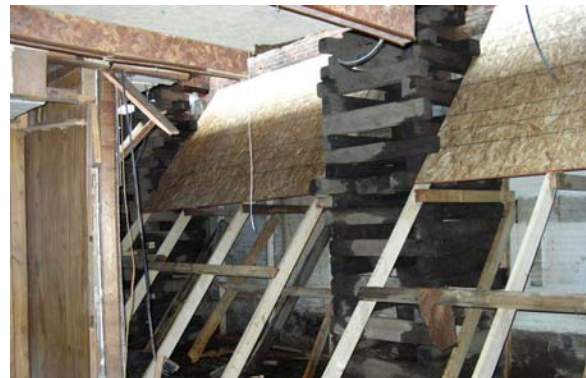
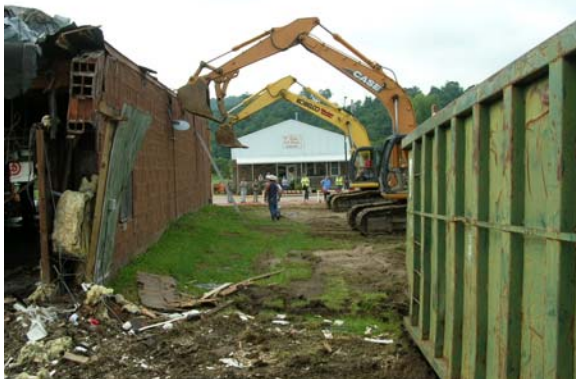
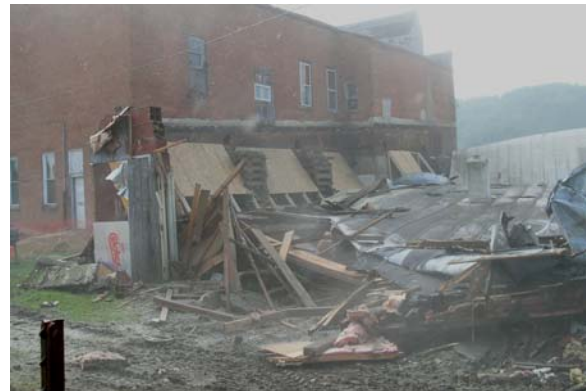
The existing bowling alley roof framing elements were disconnected from the adjacent existing Opera House building as outlined within the demolition documents prepared by MSA. The existing trusses were jacked-up slightly and re-supporting by cribbing which consisted of stacked wood railroad ties. While the cribbing did not match the suggest means of support depicted on the demolition documents, it was deemed acceptable in the field. A series of wood bracing assemblies were installed between truss supports as depicted on the demolition documents to protect the existing Opera House walls from potential falling debris. Two excavators were attached to the bowling alley roof trusses via a system of chains. The excavators pulled the existing roof framing to the west until it was able to fall to the ground as depicted on the demolition documents. A portion of the southern wall remained mostly upright after the roof framing fell. The wood bracing assembly at the southeastern corner acted as a shoring device restraining the wall from falling to the north. An excavator was used to peck away at the southern wall and brace until the construction was demolished. No damage to the existing Opera House building was observed associated with the demolition effort.
